### **Through Bushing Inspection System**

IMTT's Bushing Inspection System provides a unique and innovative approach to detecting these under bushing cracks ...

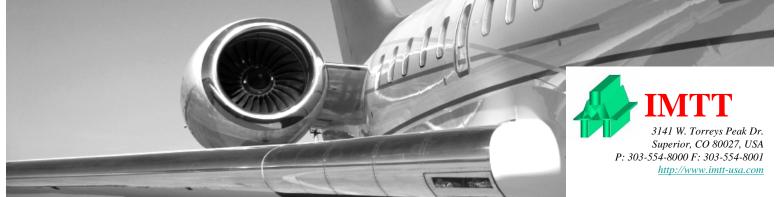
# NO BUSHING REMOVAL REQUIRED HIGH SENSITIVITY SUPERIOR EFFICIENCY & RELIABILITY

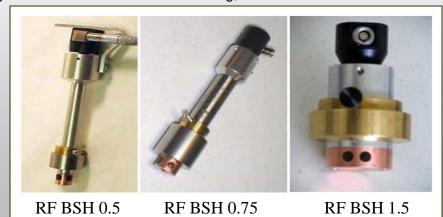
RF BSH 0.5 in Test

## **High Sensitivity RFEC Bushing Probes for Manual Scan**

- ➤ Through 0.032" 0.125" thick Inconel-718 bushing;
- ➤ Through 0.080" thick Al-Ni-Bronze bushing;
- > Through 0.080" thick Al-Ni-Bronze bushing;

0.050" crack on Al lug 0.100" crack on Steel lug 0.150" crack on Al lug

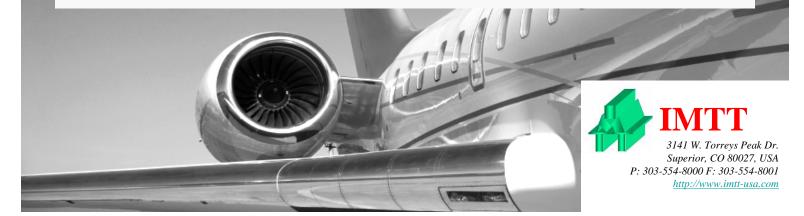
## **Automated Bushing Scanners**

- ➤ Completely automated inspection procedure
- >Sophisticated algorithm removing background noise
- >Automated crack identification

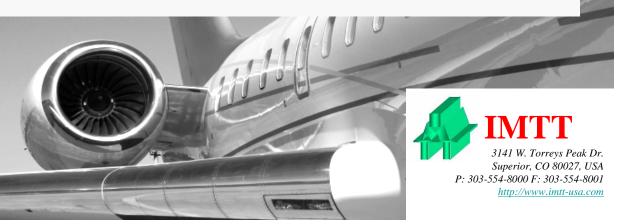
# Typical Results for Automated Busing Inspection System BSH 0.5 Aircraft Wing Attach Fitting Cracking

Example #1: Detection of crack on real aircraft sample aluminum lug under the Inconel 718 bushing (ID = 0.50"; T = 0.063")

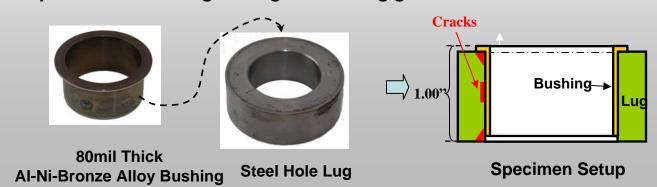
## Specimen simulating Boeing 767 landing gear Cross-Bolt Hole

Detection of EDM notch on a steel lug under the Al-Ni-Bronze bushing (ID = 1.50"; T = 0.08")

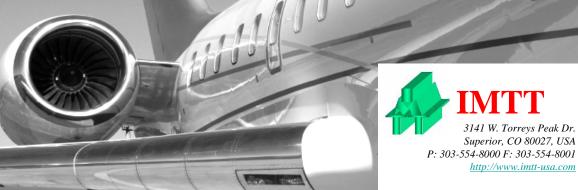
#### **Automated Bushing Inspection System BSH 0.5**

- ➤ Bushing ID size from 0.35"—0.60" upon customer request
- > Through 0.032"—0.125" thick Inconel-718 bushings
- > Detect crack as small as 0.06" × 0.02" through 0.063" thick bushing in aluminum substrate
- Possible working with other bushing materials
- Built-in 2-axis motor controller
- > Built-in real-time crack identification software
- Completely automated inspection procedure
  - Automatic locating predetermined scan areas
  - Automatic loading predetermined instrument settings
  - Automatic image display
  - Automatic noise removal and crack identification
  - 2-Dimentional crack image display

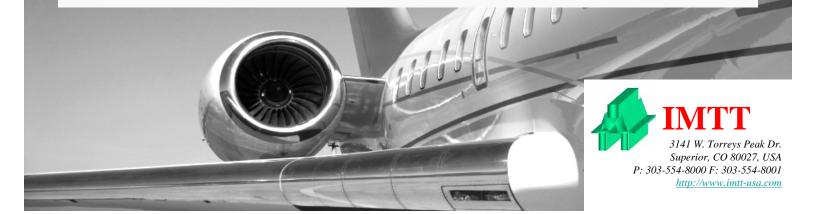
#### Instrument SSEC II-S

- A modification of conventional eddy current instrument
- A computerized software system by connecting the instrument to a PC through a USB connector
- Accommodate IMTT's FG RFEC probes and all other conventional eddy current probes
- Increased sensitivity
- Enhanced functions including:
  - Automatically optimizing drive current and pre-gain at given frequency
  - Added a new probe mode simulated differential reflection mode for better background noise removal
  - Built-in custom signal processing algorithms
- > Capable of control up to two step motors
