Thick Multiple Layers Aircraft Structure Crack Detection Using FG_RFEC Sliding Probes

IMTT's FG_RFEC Sliding Probes Can Also Used for Crack Detection in Thick Multilayer Aircraft Structure

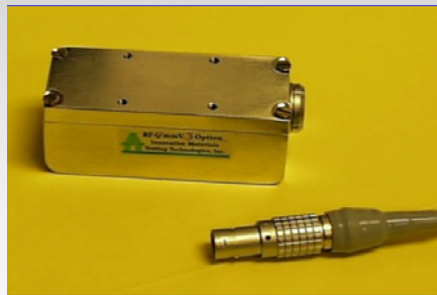
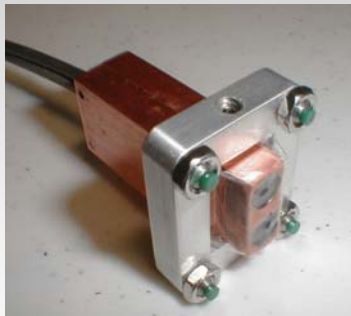
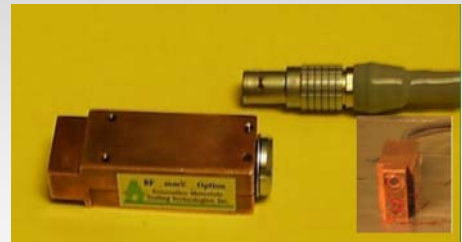
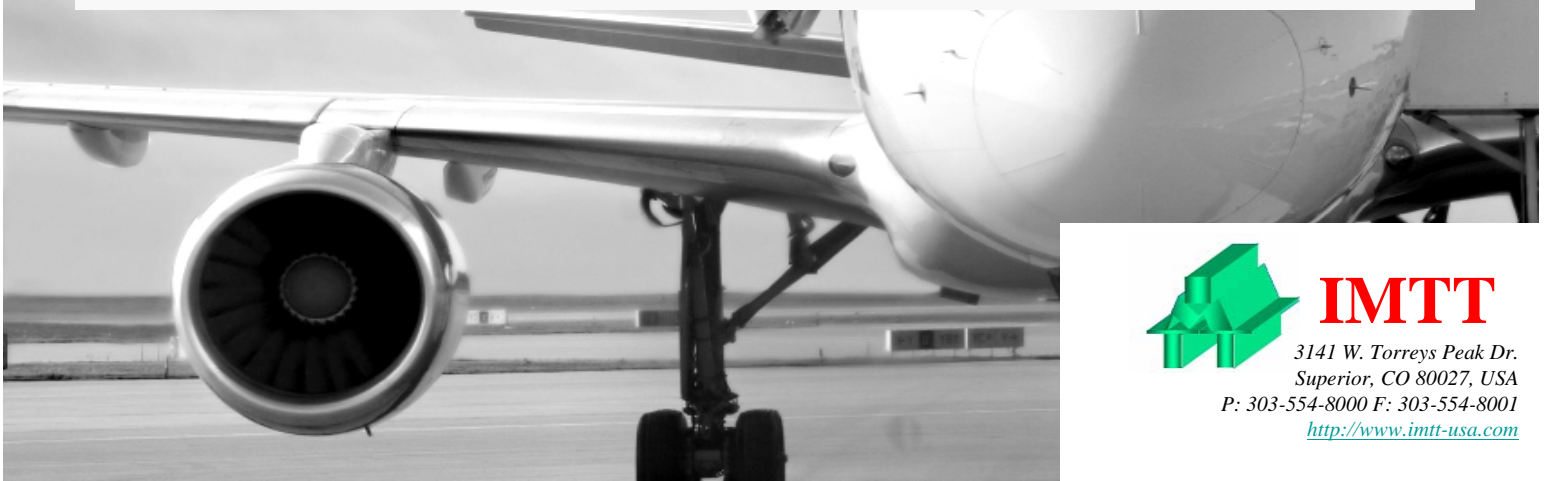
**SURFACE ACCESS EXTERNAL INSPECTION
HIGH SENSITIVITY & RELIABILITY**

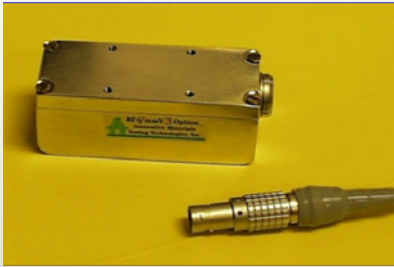
RF4 V3.A

Footprint: 0.85" x 2.15"

CCD = 1.15"*

*CCD – Drive Coil Center to Pickup Coil Center Distance

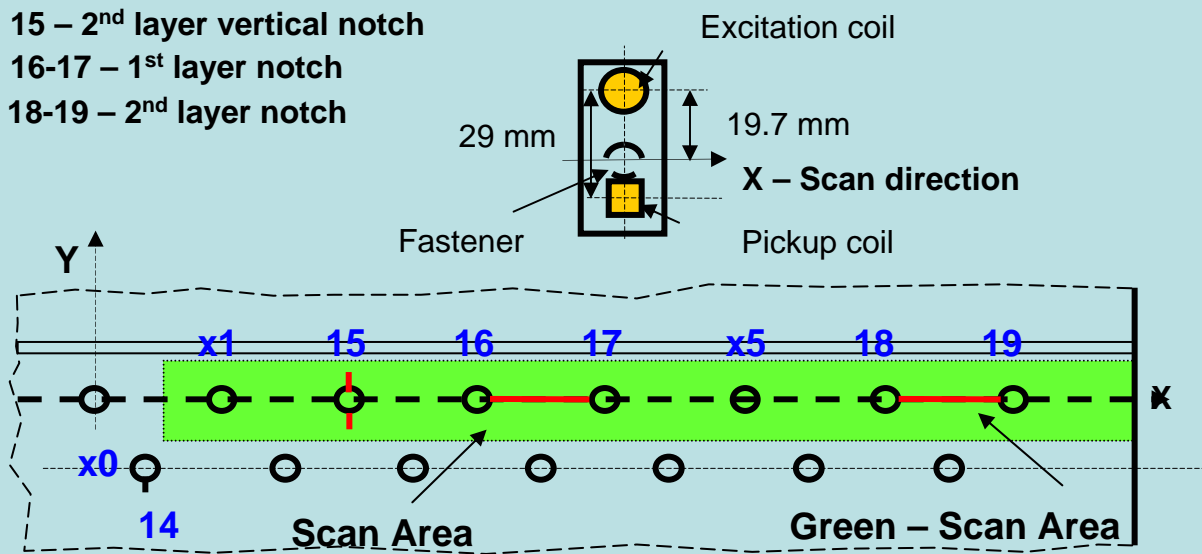
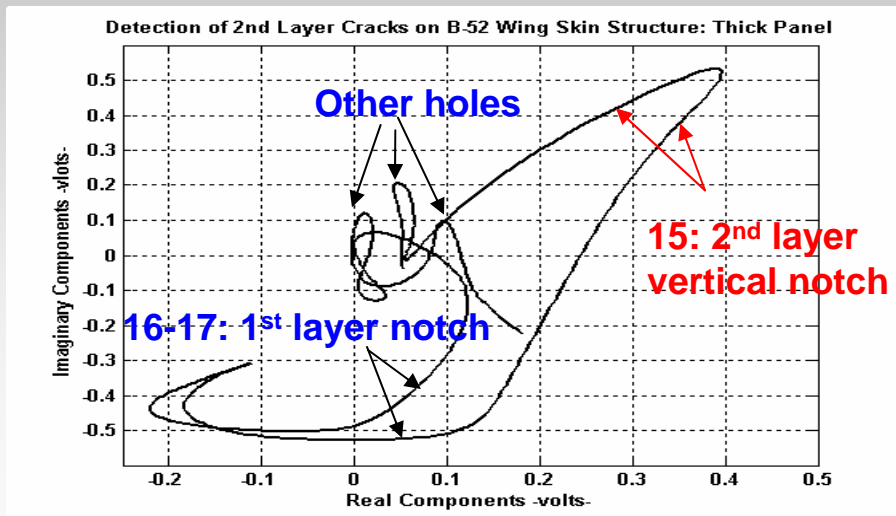
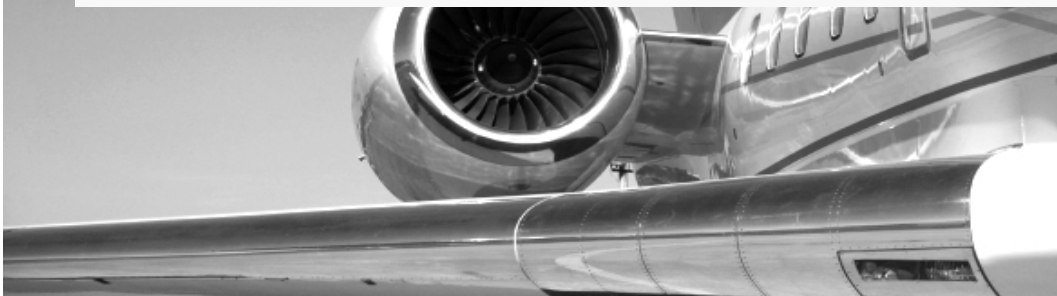
Example – Detecting 2nd Layer Crack at Fastener #15 in 0.25" + 0.25" Thick B-52 Wing Spar Structure

15 – 2nd layer vertical notch

16-17 – 1st layer notch

18-19 – 2nd layer notch

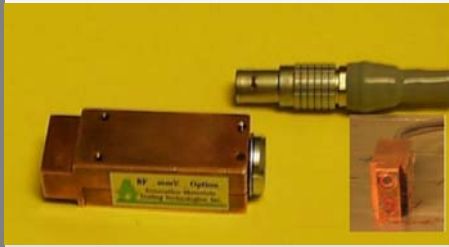
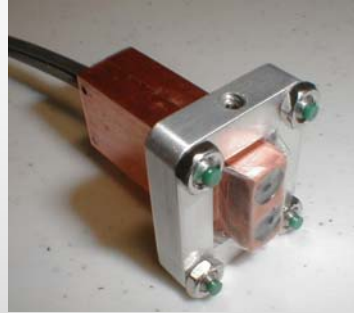
RF2 V3.A

Footprint: 0.30" x 0.62"

CCD = 0.30"*

***CCD – Drive Coil Center to Pickup Coil Center Distance**

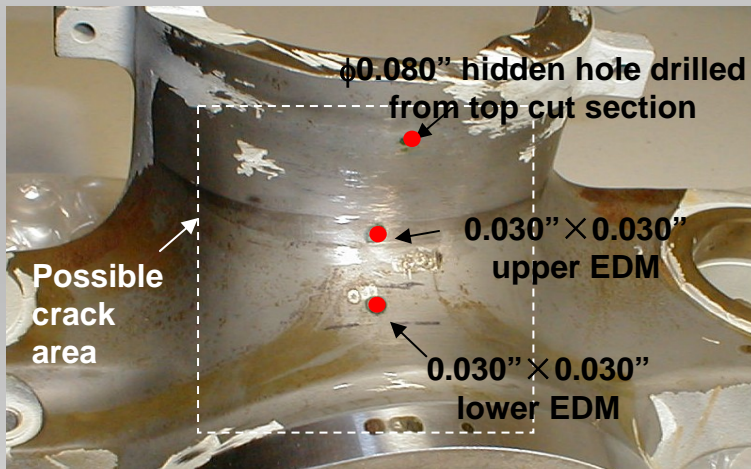
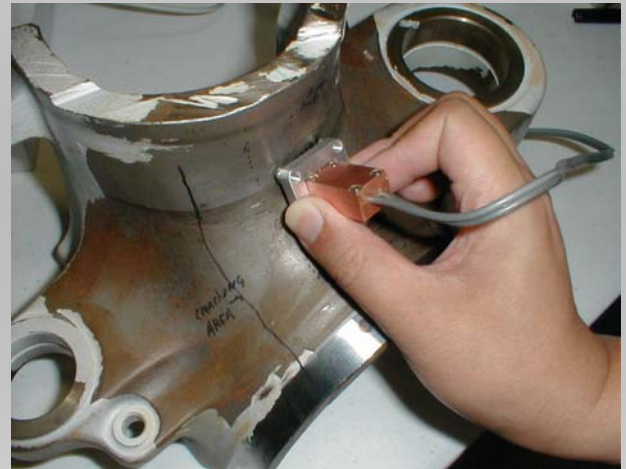
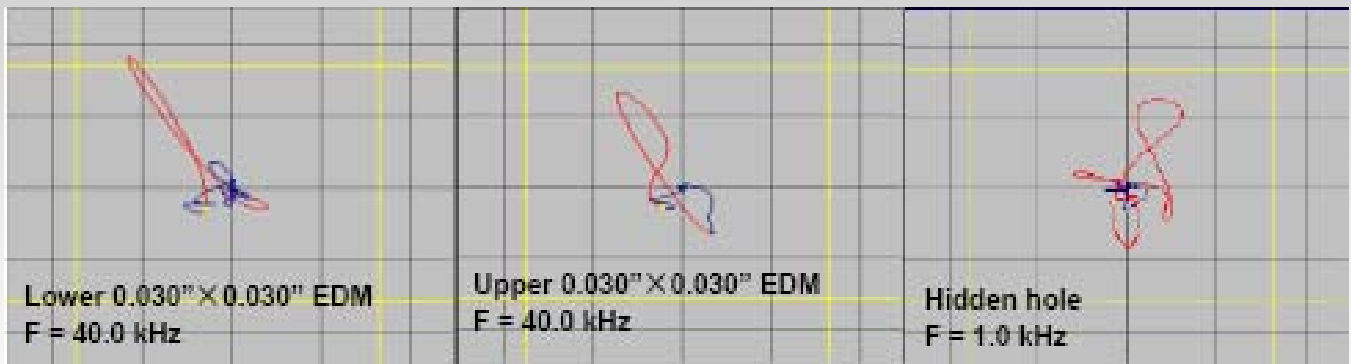
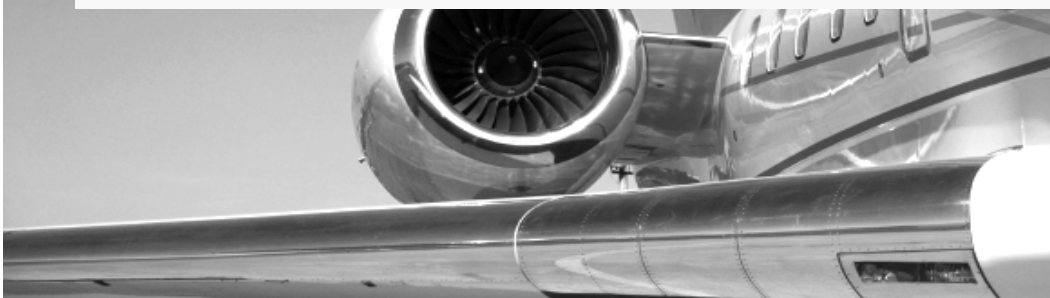
Example – Detecting Surface Crack and Hidden Defect on Complex Landing Gear Structure of AIRBUS A320
