# ASIP 2006

## Lower Layer Crack Detection in Thick Complex Aircraft Structures Using Flat Geometry Remote Field Eddy Current Technique

Capt DJ Butcher, Canadian Forces Aerospace and  
Telecommunications Engineering Support Squadron (ATESS)  
Mr. Yushi Sun, Innovative Materials Testing Technologies (IMTT)

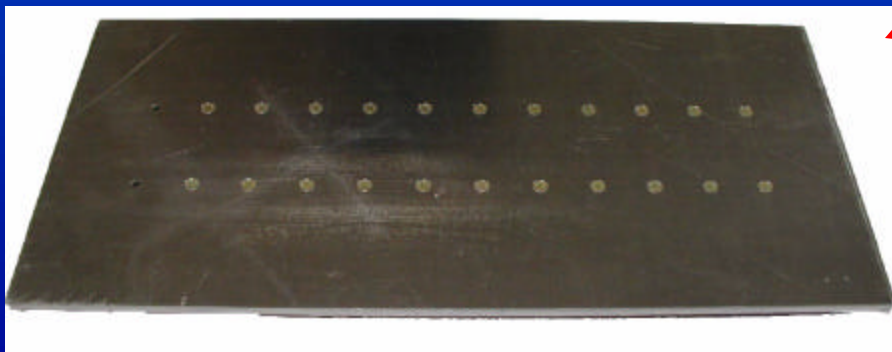
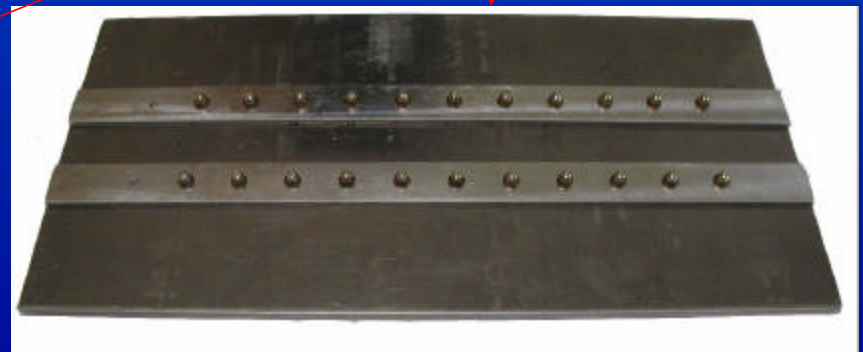
# Problem #1 – CC130

- Each lower surface of the CC130 CW box is comprised of 3 skin panels ranging in thickness from 0.150" to 0.175" fastened to hat sections of approximate thickness 0.140"
- Test Piece represents the skin and stringer (skin Al 7075-T7351 0.250" thick, stringer feet same material 0.140" thick with ferrous fasteners)

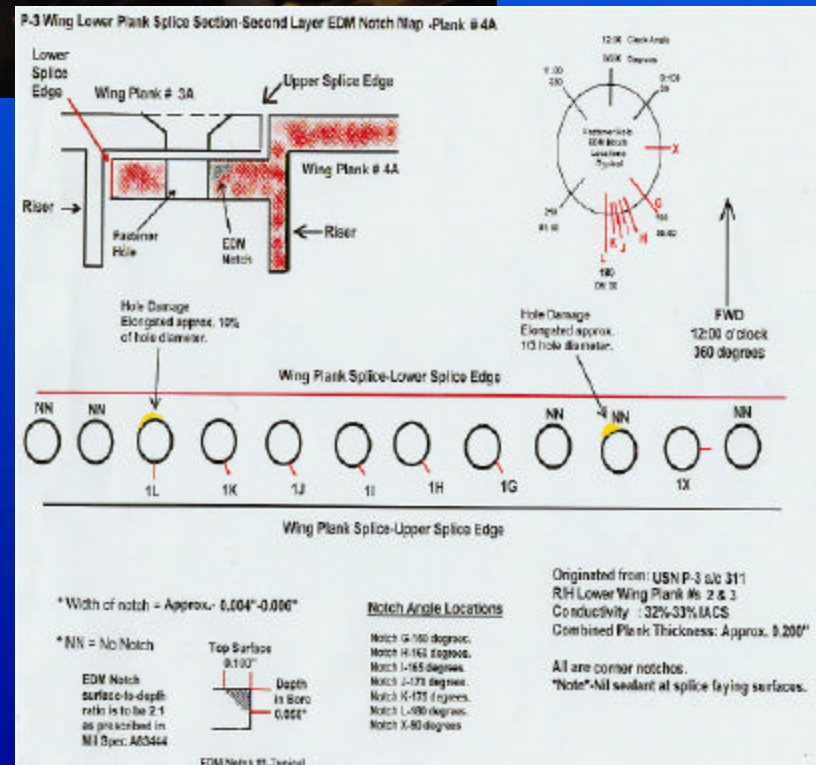
# Problem #2 – CP140 (P3)

- The lower wing skins of the CP140 involve extruded planks with risers (vice stringers) and typically a single row of ferrous fasteners
- Skin thickness typically vary from 0.080” – 0.320”
- Test piece represents wing splice with first layer thickness of X and second layer thickness of Y

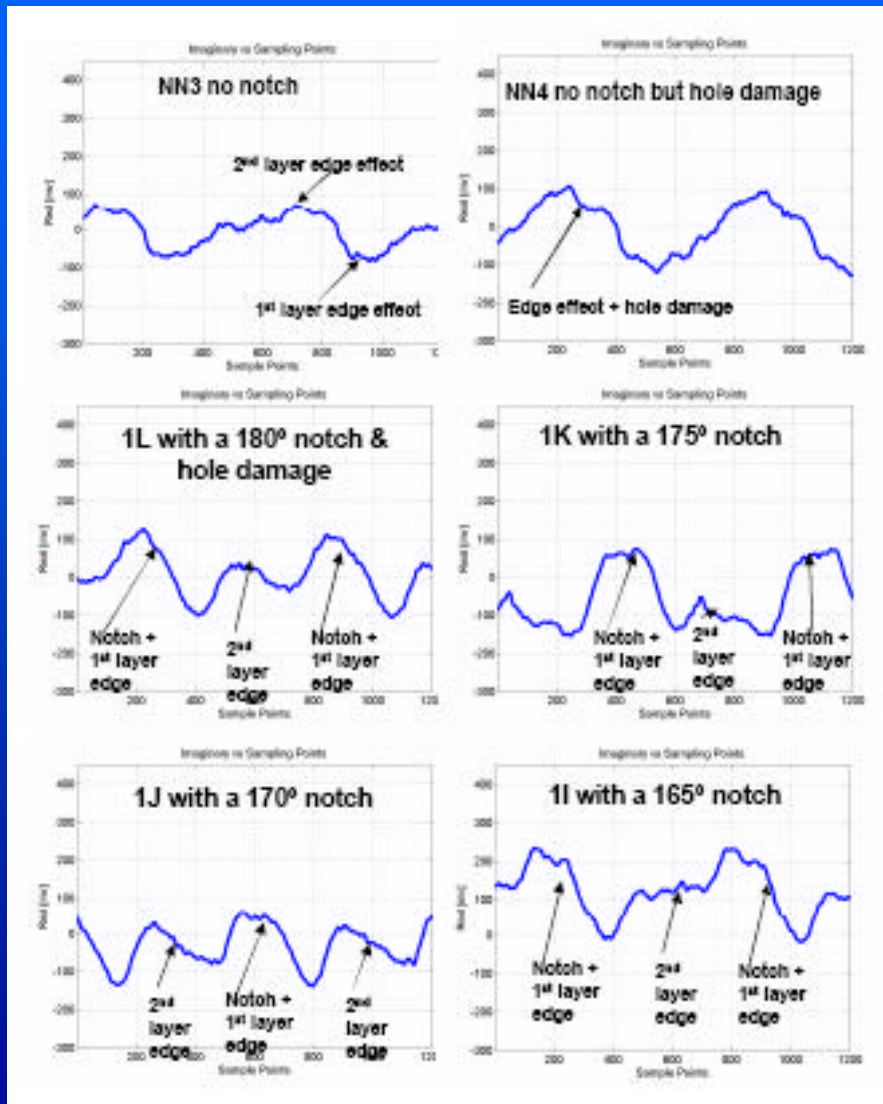
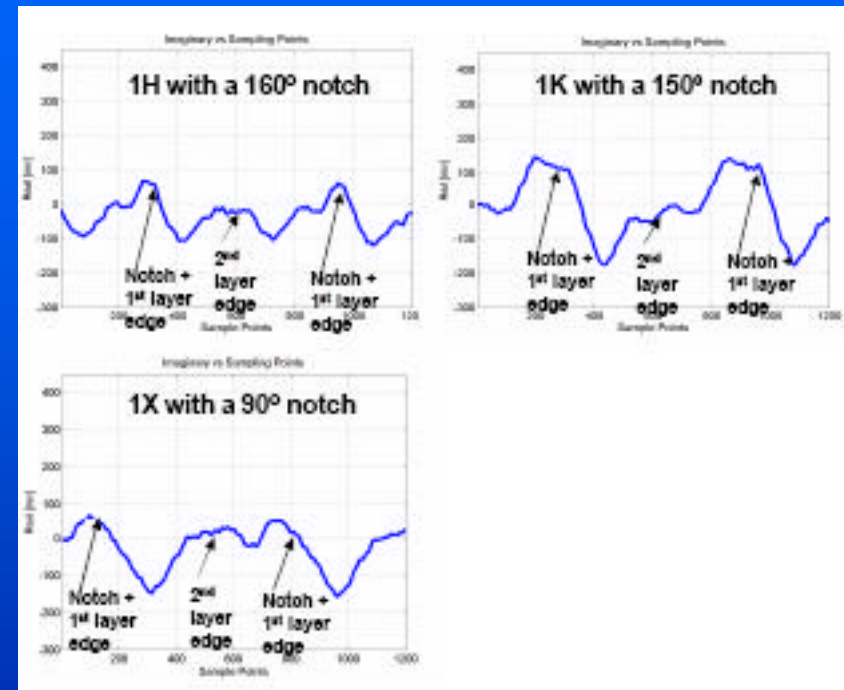
# Imaginary Component of Impedance Planes for 2<sup>nd</sup> Layer Defects in the P3 Test Piece (Corner Notches)

All the EDM notches are the same size. Variances in signals occur to the notch proximity to the 1<sup>st</sup> and 2<sup>nd</sup> layer edges. Note the increase in amplitude and increase in slope for the notched. (Driving frequency=1.6kHz)

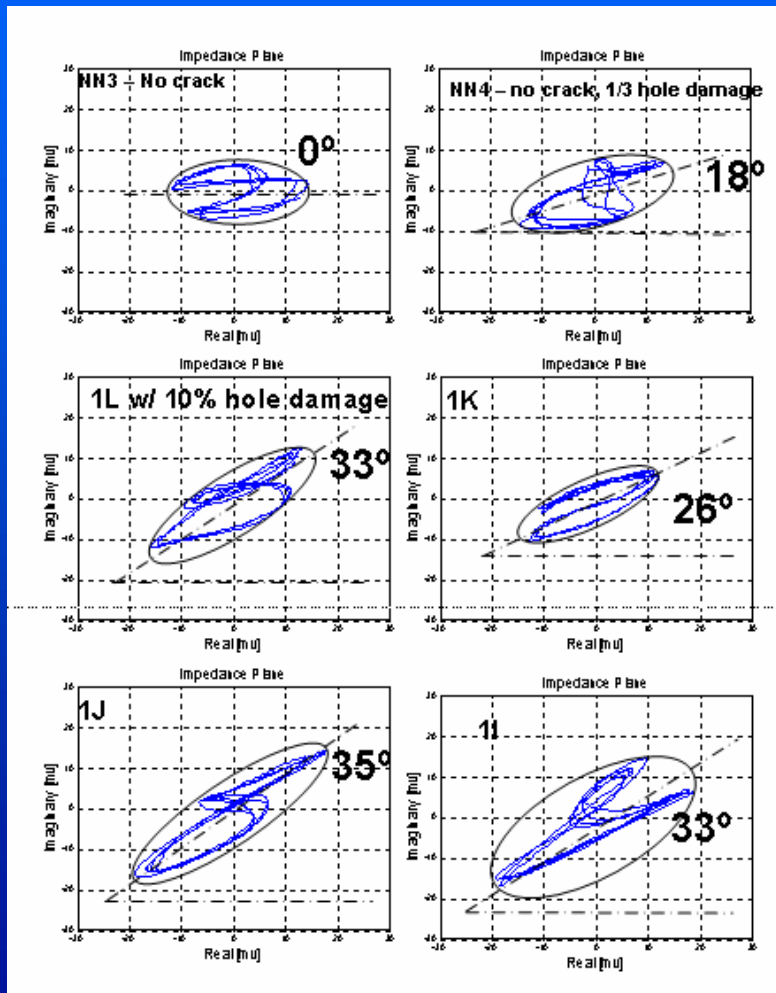
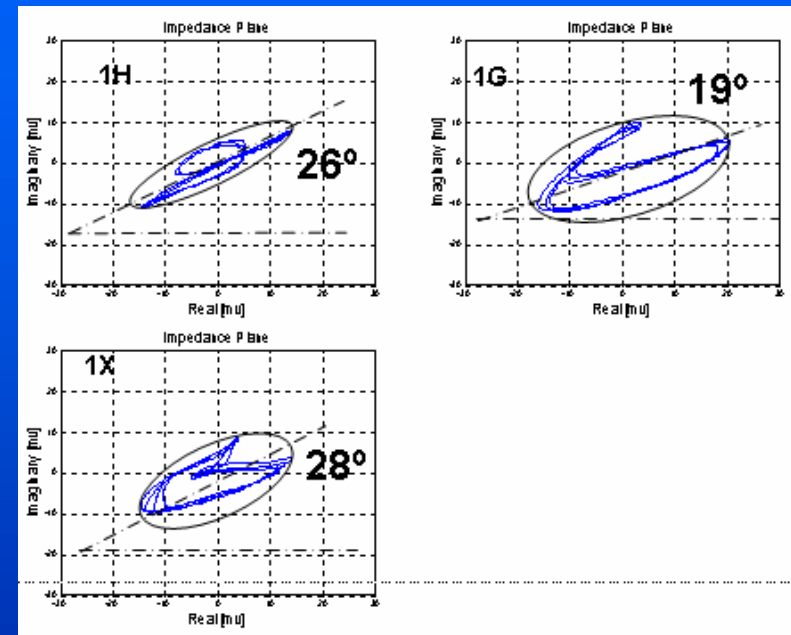
# Imaginary Component of Impedance Planes for 2<sup>nd</sup> Layer Defects in the P3 Test Piece (Corner Notches)

All the EDM notches are the same size. Variances in signals occur to the notch proximity to the 1<sup>st</sup> and 2<sup>nd</sup> layer edges. Note the increase in phase angle in impedance plane for the notched. (Driving frequency=0.8kHz)

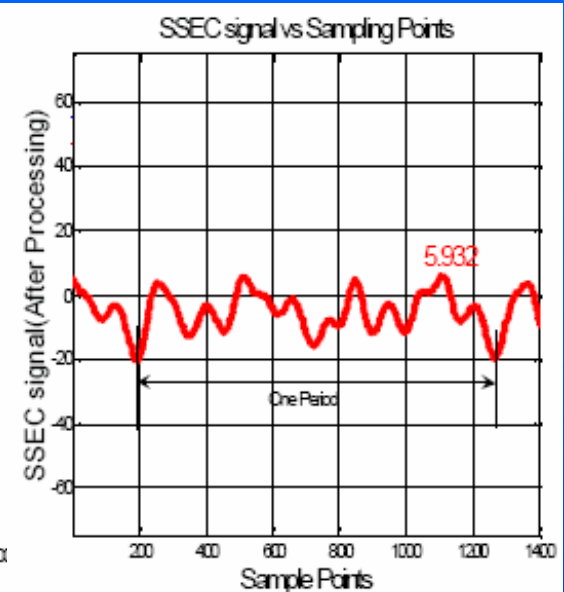
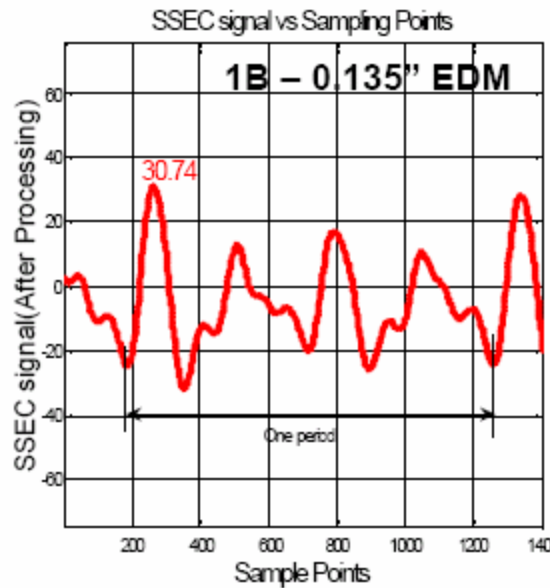
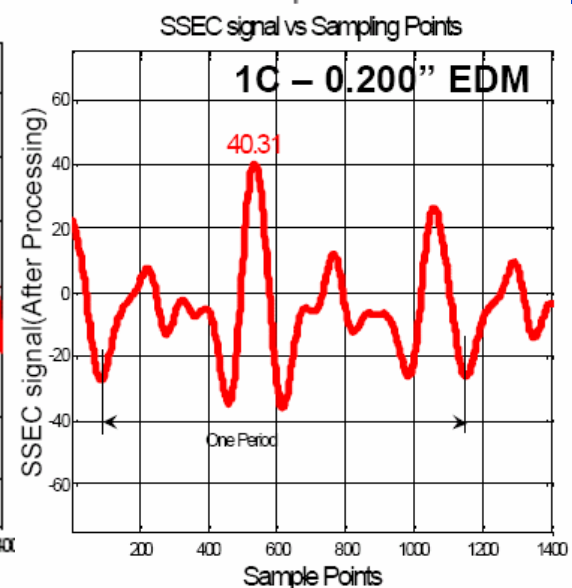
# Imaginary Component of Impedance Planes for 1st Row Defects in the F18 Test Piece (Through Notches)

- EDM notches as small as 0.135” were detected in 0.134’ aluminum through 0.750” of composite material with an S/N > 3.
- Test results were influenced by nearby fasteners and the sealant groves (edge effects) in the second layer
  - Can be overcome by probe offset or probe enhancements

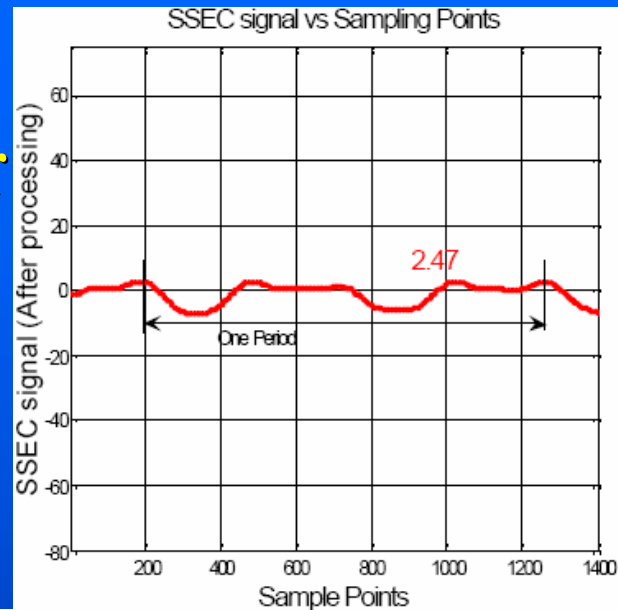
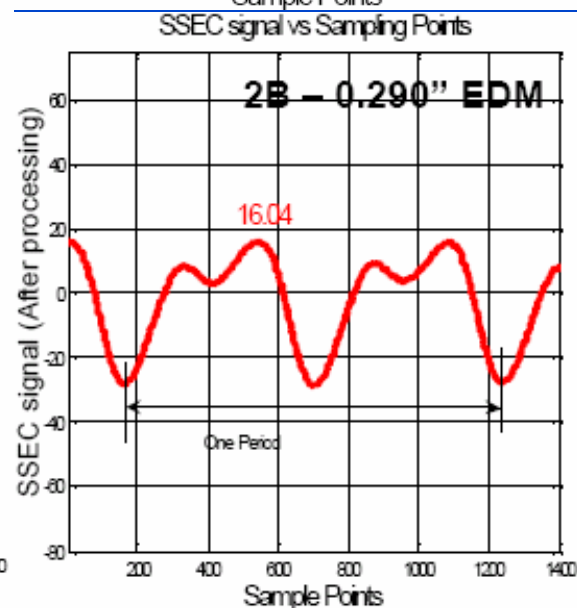
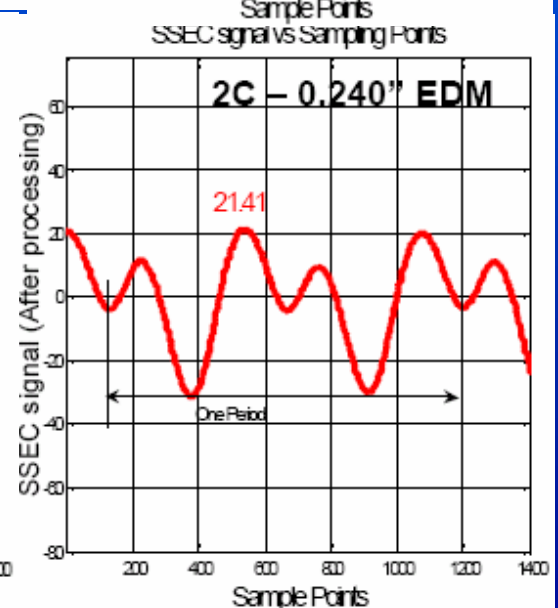
# Imaginary Component of Impedance Planes for 2nd Row Defects in the F18 Test Piece (Through Notches)

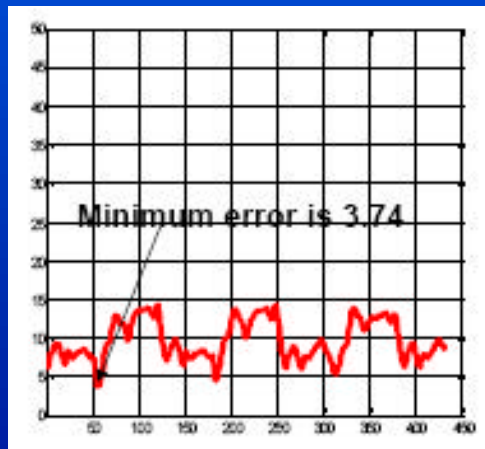
- Application of reference subtraction variation
  - Use wavelet method to do the fit every 10 points
  - For every fitting calculate RMS error
  - Plot RMS error

Fastener with no defect: low RMS error

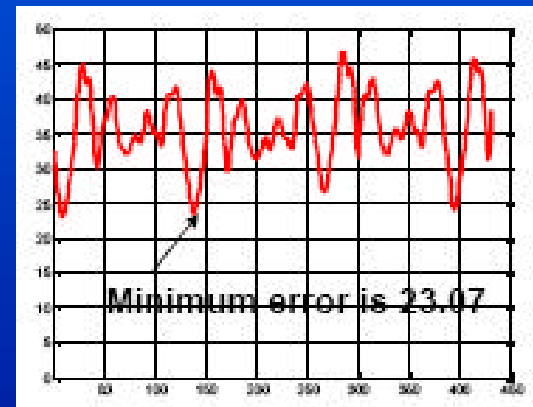
Fastener with 0.120" x 0.200" EDM Notch: large RMS error
