FG RFEC Technique for Thick Multilayer Aircraft Structures Inspection

Part III Thru Composite Crack Detection

Yushi Sun
Innovative Materials Testing Technologies, Inc.
3141 W. Torreys Peak Drive
Superior, CO 80027
Tel: 303 554 8000
Fax: 303 554 8001
Email. Suny@imtt-usa.com

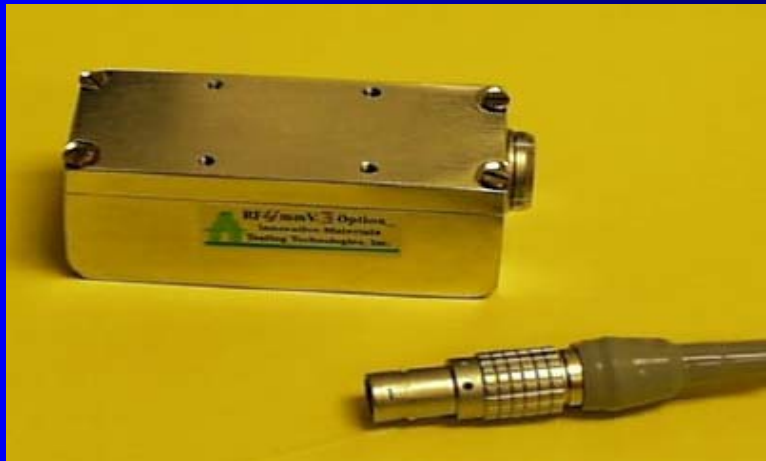
RF4 V3

Footprint: 0.85" x 2.15"
Coil Center-to-Center Distance,
CCD = 1.15"

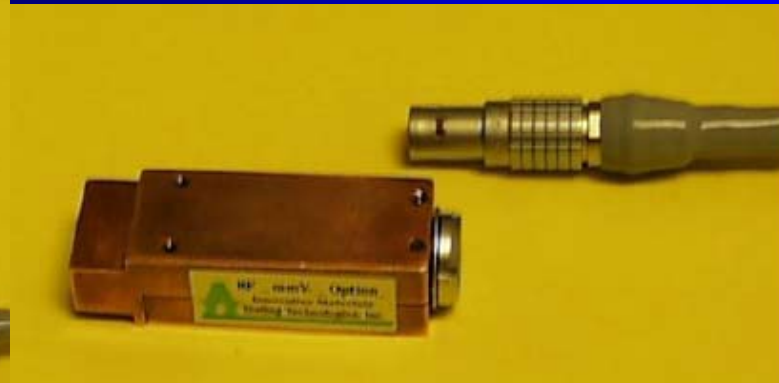
RF2 V3

Footprint: 0.3" x 0.62"
Coil Center-to-Center Distance,
CCD = 0.3"

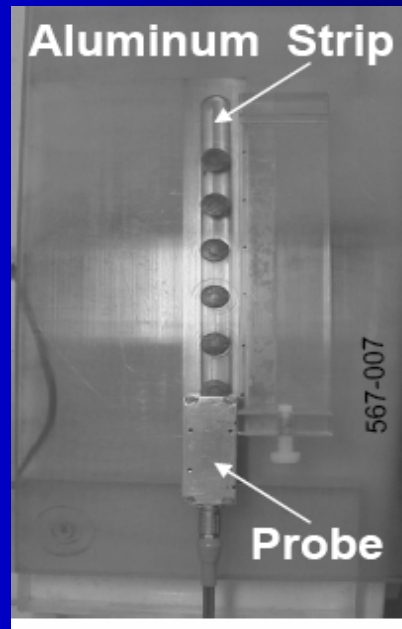
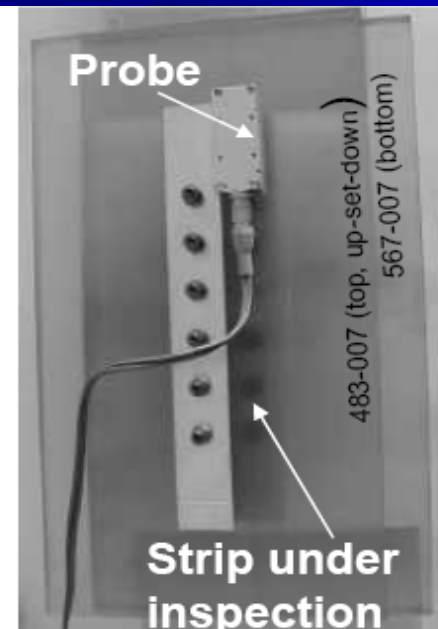
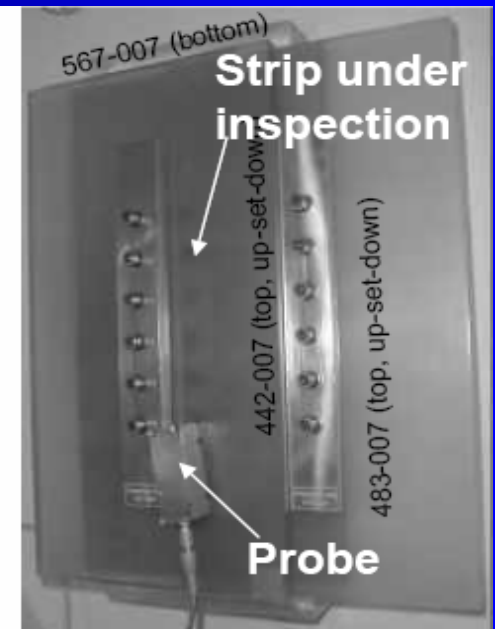
Example #1: Detection of aluminum layer crack through 1.5” of polycarbonate using sliding probe RF4 V3A*

Three 7”x13” polycarbonate pieces with thicknesses:

- 567-007 – 0.567”;
- 483-007 – 0.483”
- 442-007 – 0.442”

A 9.0”x1.25”x0.20” aluminum strip attached below each of them
Titanium fasteners

One layer

Two layers

Three layers

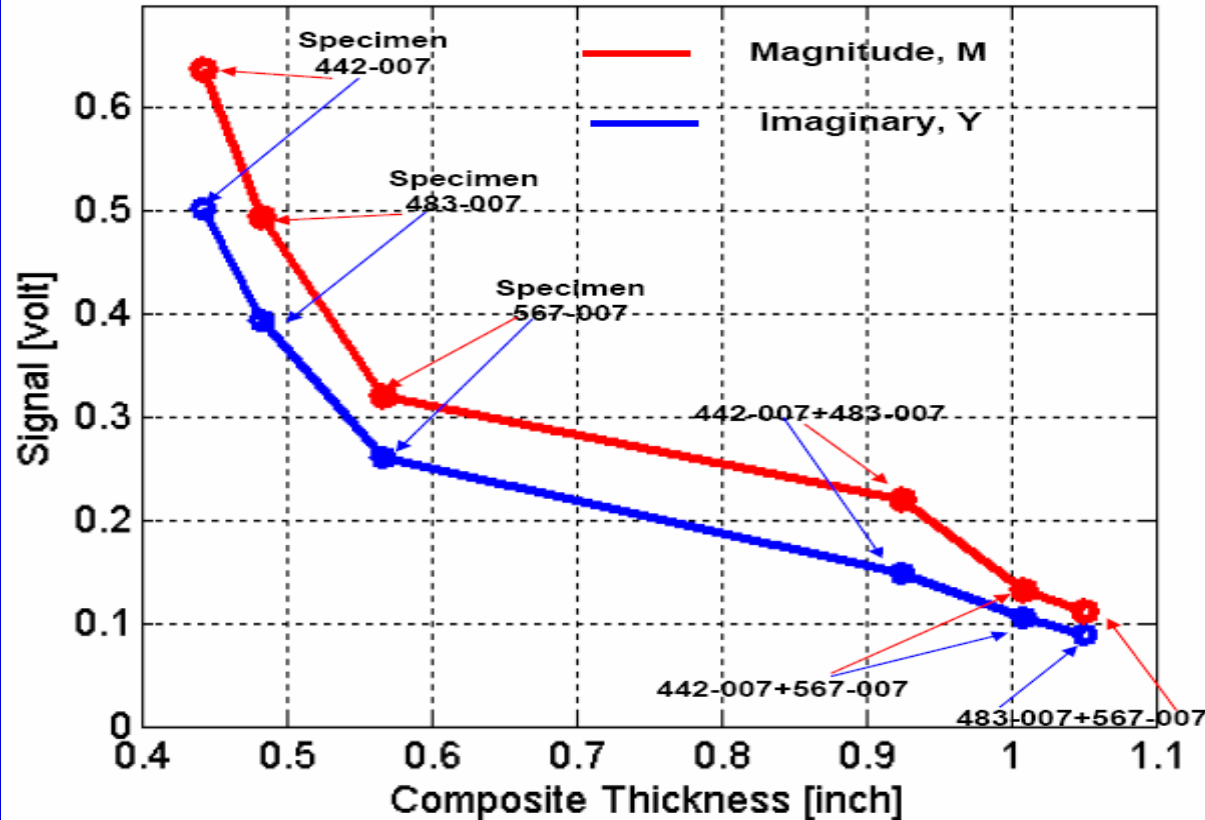
8. A Complete Signal – Thickness Relation Curve at $f = 2.0\text{kHz}$

Crack Signal vs Composite Thickness

- 1. The two EDM notches in the aluminum strip can be detected through polycarbonate layers with a total thickness of up to 1.050” at $f = 2.0$ kHz using the FG RFEC sliding probe RF4 V3A**
- 2. The two EDM notches can be detected through polycarbonate layers with a total thickness of up to 1.500” at $f = 0.2$ kHz using the FG RFEC sliding probe RF4 V3A**

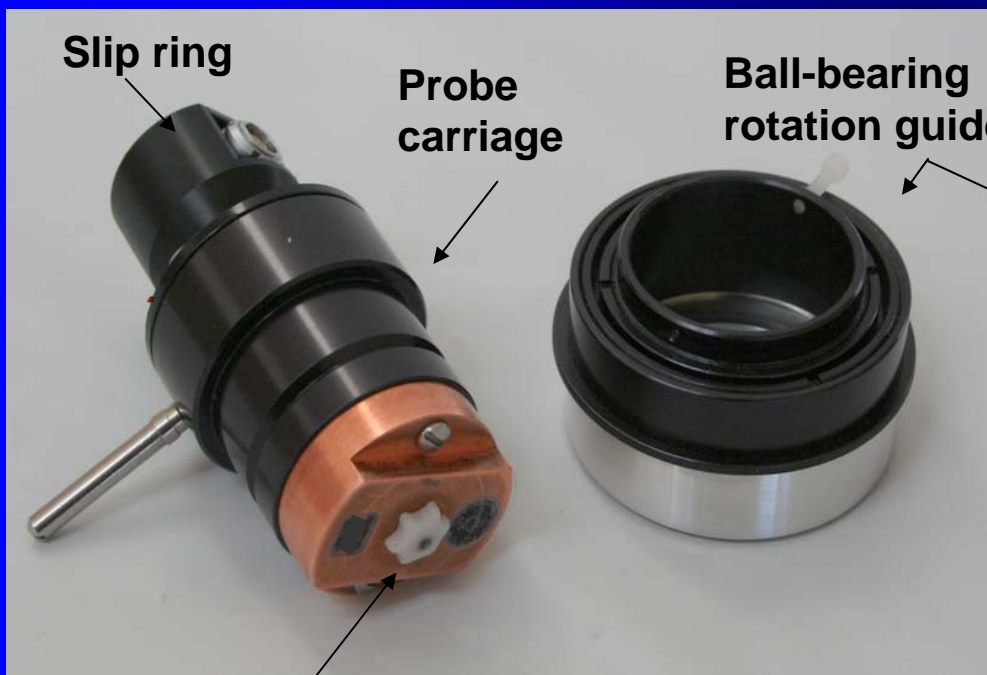
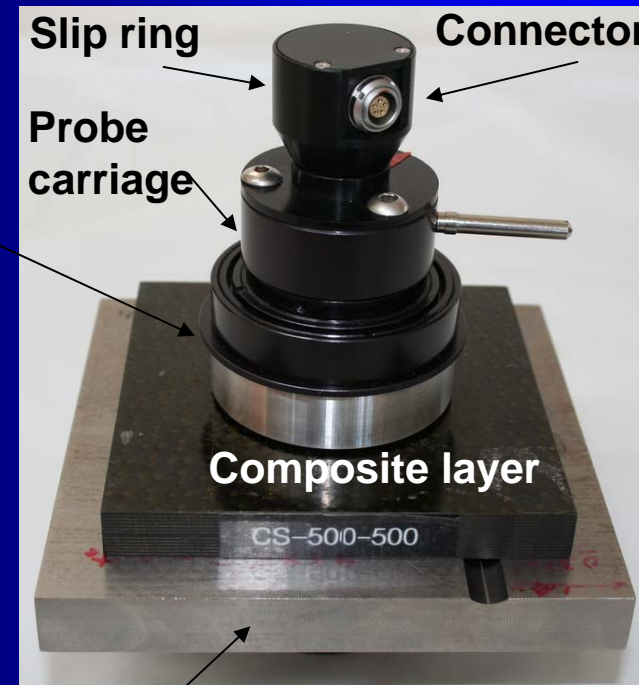
Newly Developed Manually Rotary Probe and Accessories

Probe head with centering pin

Titanium layer under inspection

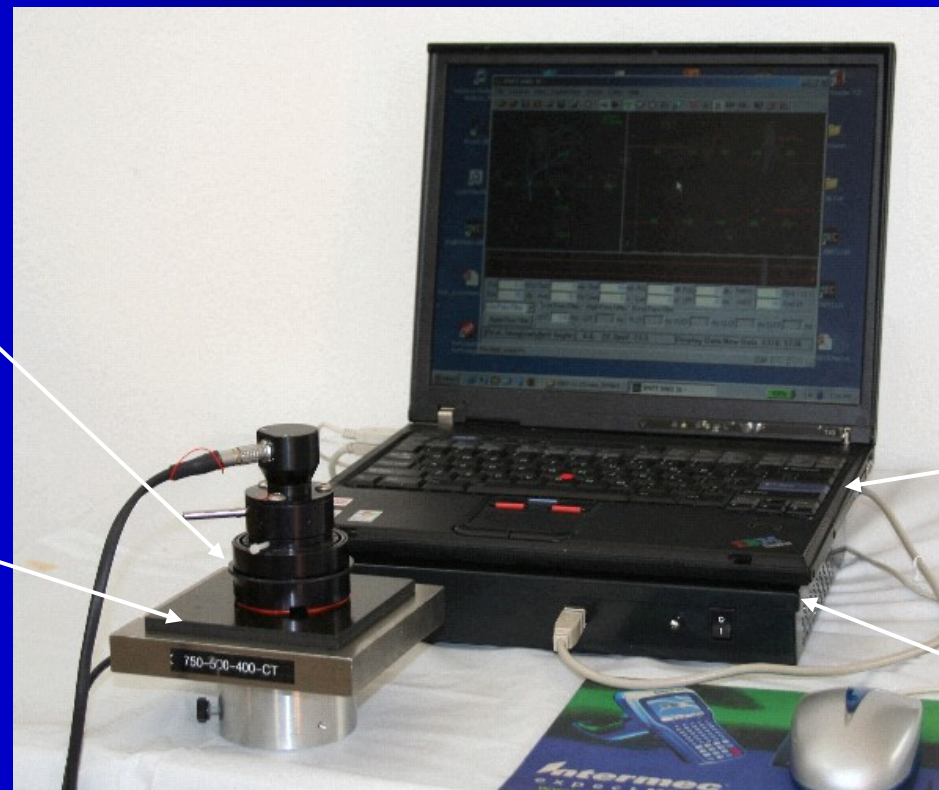
Complete SSEC System for Thru Composite Crack Detection Using Rotary Scanner

Automated
Rotary
Scanner

Specimen
under
inspection

Laptop

Instrument
SSEC II-S

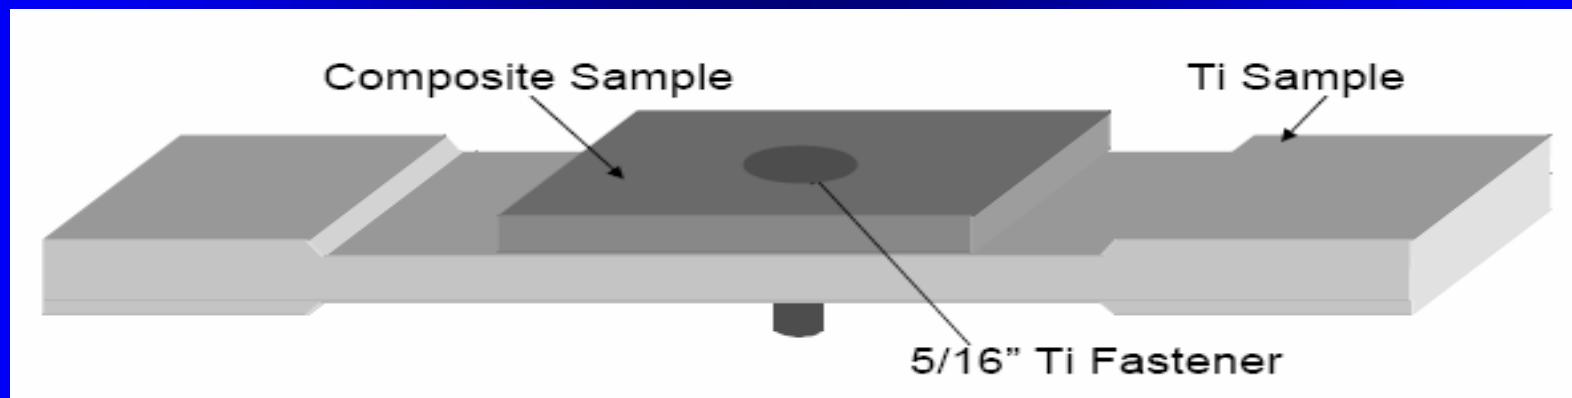
Specimens

**Example #3: Detection of titanium layer crack
through 0.25" – 0.50" graphite epoxy composite*
Using rotary probe RF4 ROT**

Fatigue Crack sizes: 0.250", 0.500" and 0.750"

Composite Thickness: 0.250", 0.333" and 0.500"

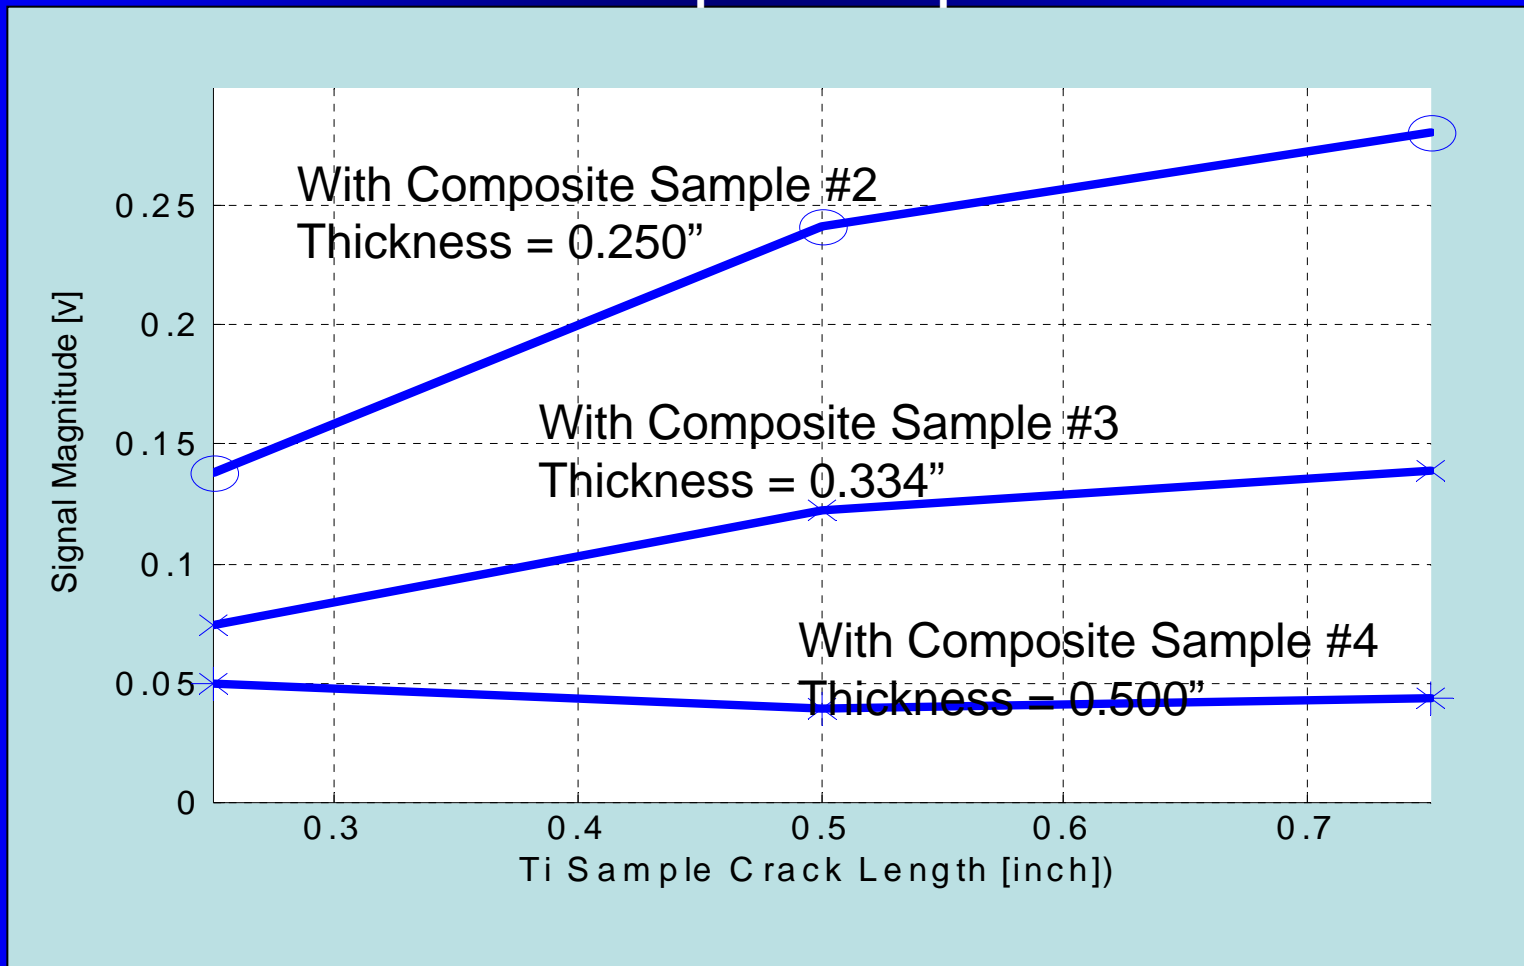
Summary for Example #3

Cracks are detected in all composite-Ti-specimens combinations

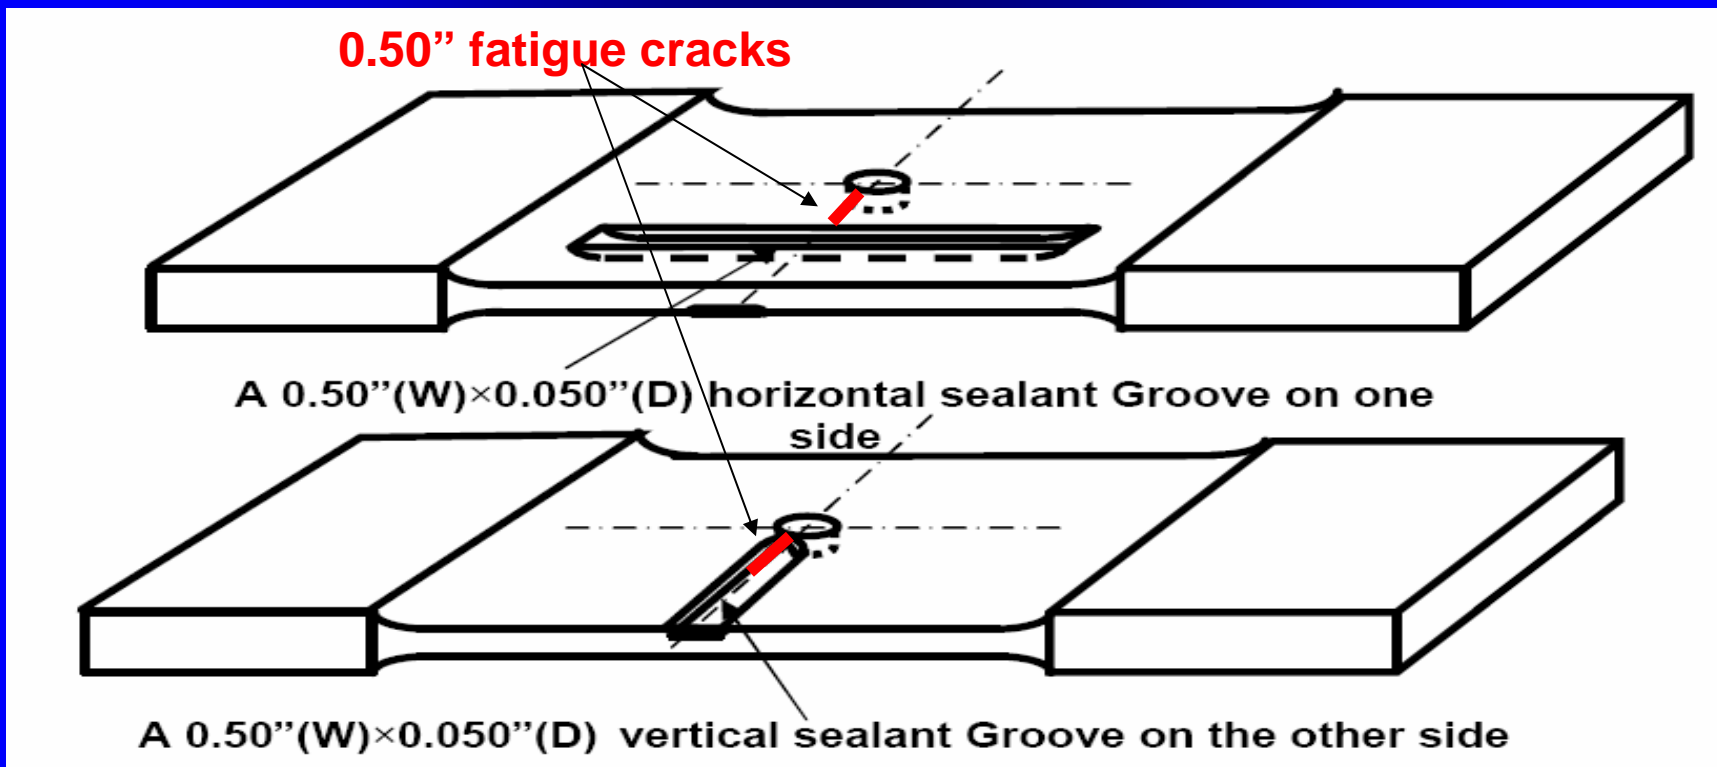
Specimen

Example #4: Detection of Ti layer crack through graphite epoxy composite and suppression of sealant groove signals*

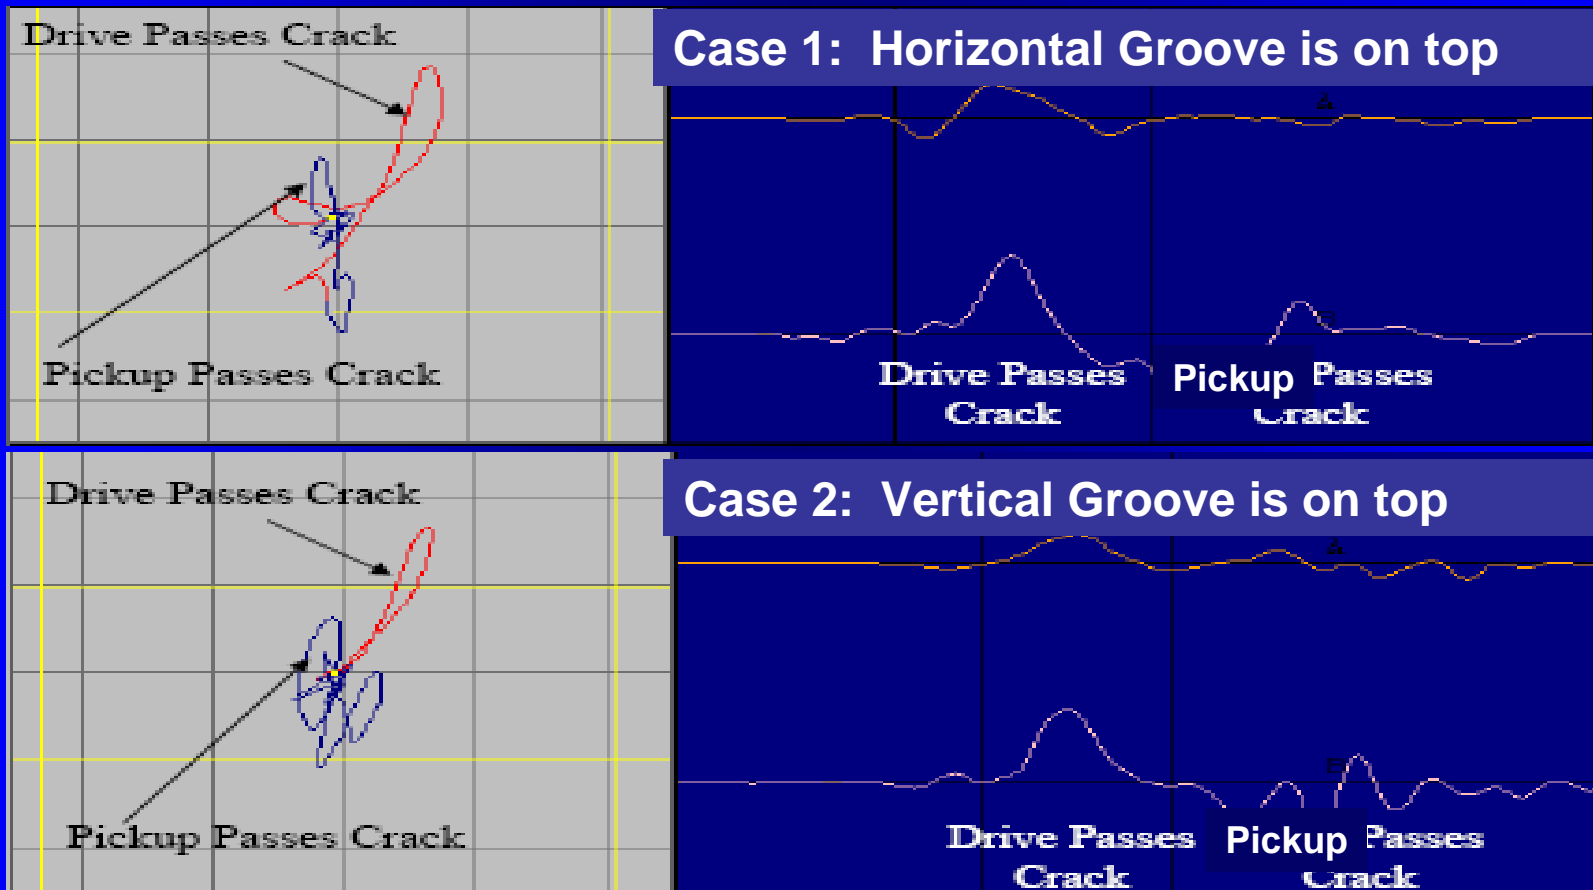
Screen Cuts from SSEC Window

Crack detected in both cases, horizontal and vertical grooves

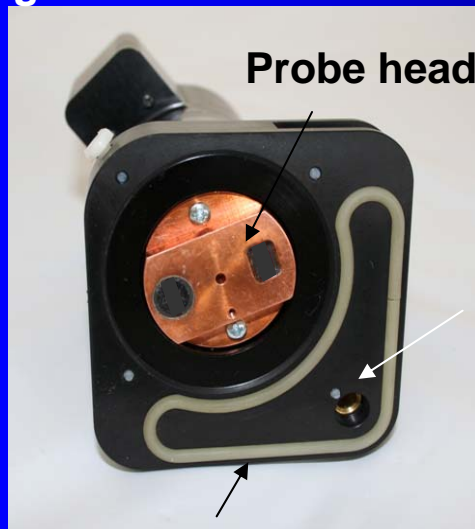
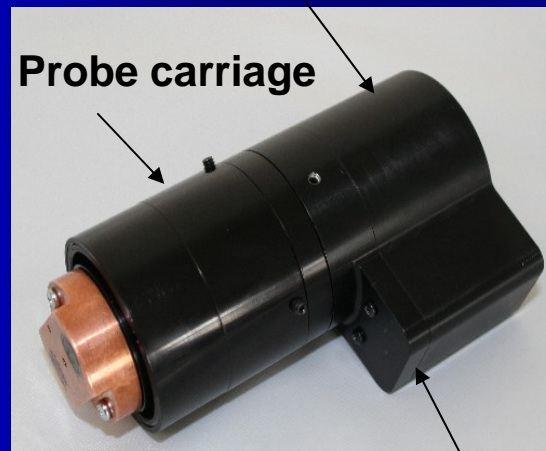
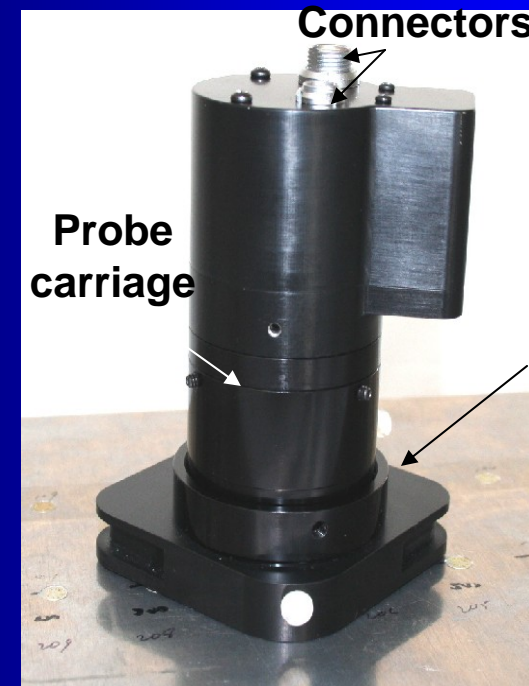
Automated Rotary Scanner and On-Line Signal Processing and Crack ID

Ball bearing rotation
guide with suction base

Sealing rubber tube

Step motor inside

Motor controller inside

Rotation
guide &
suction
base

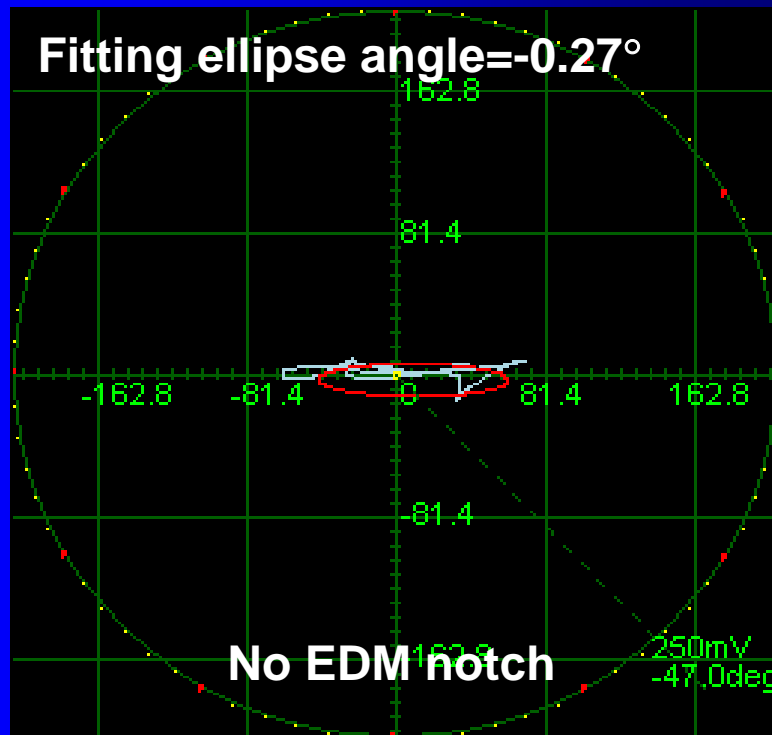
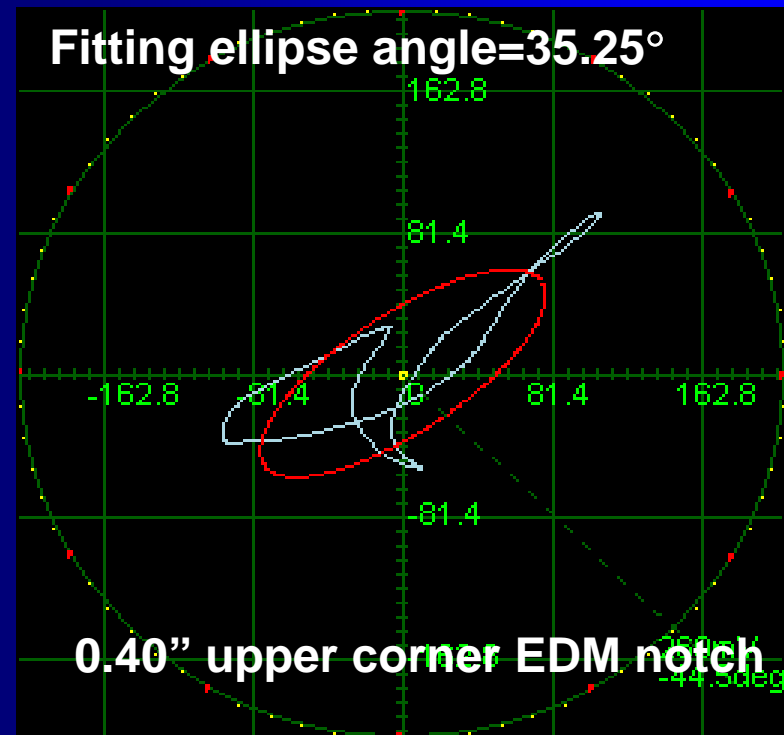
Example 1

Detecting 0.40" upper corner notch Thru 0.350" thick composite layer

A 0.35" thick composite on top of 0.60" thick Ti layer
with a curved groove
